# Uniform Mitigation Verification Inspection Form

| Inspection Date: 04/07/2021 | | |
| Owner Name: Orchard Cove Condominium Association | | Contact Person: |
| Address: Bldg. 7515, 7517, 7519 & 7521 Marsh Orchid Cir. | | Home Phone: |

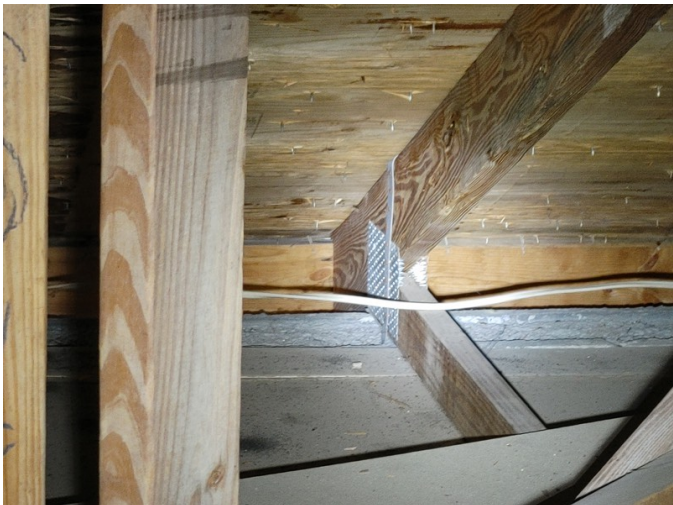
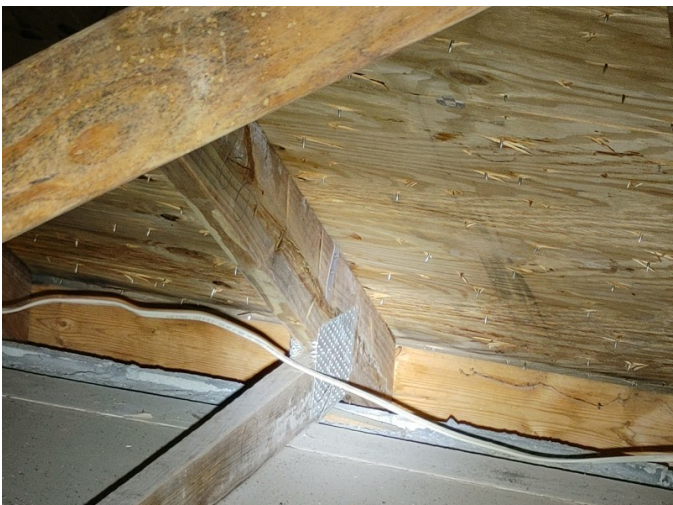
- ☒ C. Single Wraps
  - Metal connectors consisting of a single strap that wraps over the top of the truss/rafter and is secured with a minimum of 2 nails on the front side and a minimum of 1 nail on the opposing side.

Wrap with 2 nails and 1 opposite side
