# Uniform Mitigation Verification Inspection Form

| Inspection Date: 04/07/2021 | | |
| Owner Name: Orchard Cove Condominium Association | | Contact Person: |
| Address: Bldg. 7527, 7529, 7531 & 7533 Marsh Orchid Cir. | | Home Phone: |

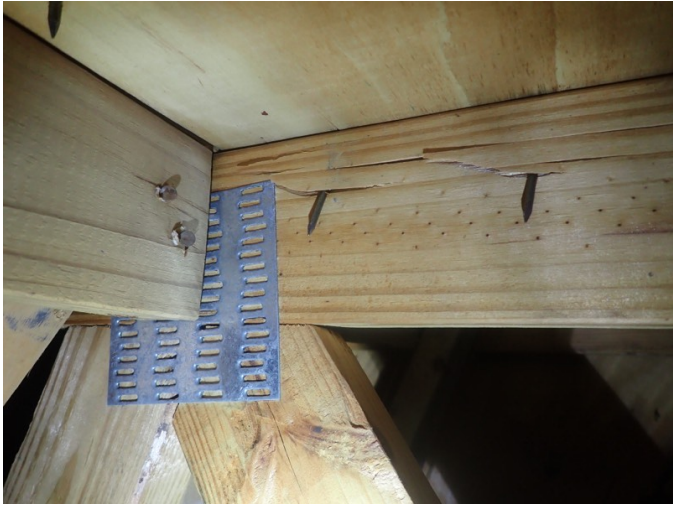
8d Nail

- ☒ C. Plywood/OSB roof sheathing with a minimum thickness of 7/16" inch attached to the roof truss/rafter (spaced a maximum of 24" inches o.c.) by 8d common nails spaced a maximum of 6" inches in the field. -OR- Dimensional lumber/Tongue & Groove decking with a minimum of 2 nails per board (or 1 nail per board if each board is equal to or less than 6 inches in width). -OR- Any system of screws, nails, adhesives, other deck fastening system or truss/rafter spacing that is shown to have an equivalent

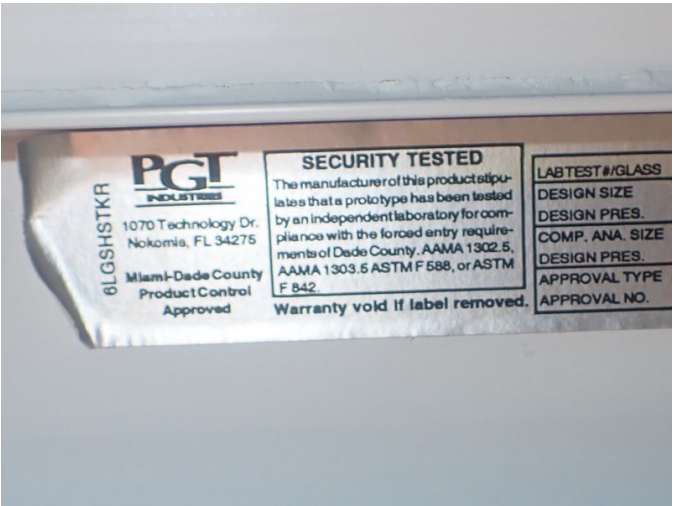
Impact rated windows

- ☒ **A. Exterior Openings Cyclic Pressure and 9-lb Large Missile (4.5 lb for skylights only)** All Glazed openings are protected at a minimum, with impact resistant coverings or products listed as wind borne debris protection devices in the product approval system of the State of Florida or Miami-Dade County and meet the requirements of one of the following for "Cyclic Pressure and Large Missile Impact" (Level A in the table above).

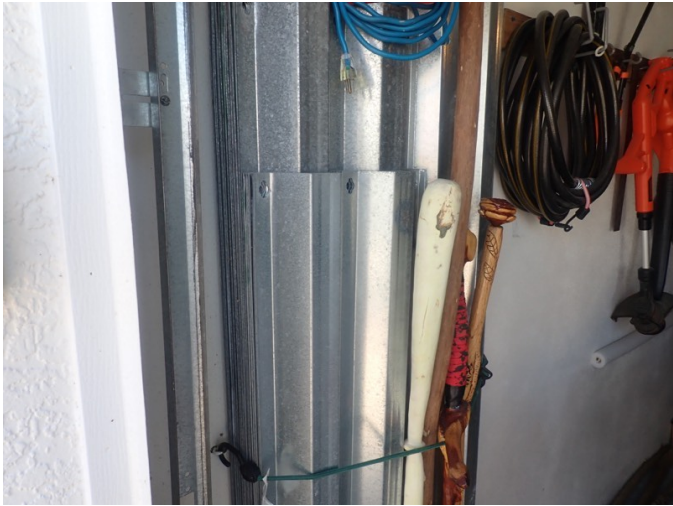
Impact rated glazed opening protection
