# Uniform Mitigation Verification Inspection Form

| Inspection Date: 04/07/2021 | | |
| Owner Name: Orchard Cove Condominium Association | | Contact Person: |
| Address: Bldg. 7616, 7618, 7620 & 7622 Marsh Orchid Cir. | | Home Phone: |

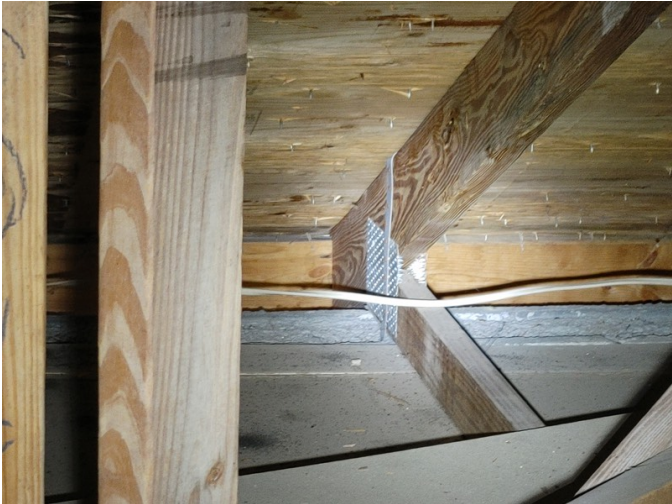
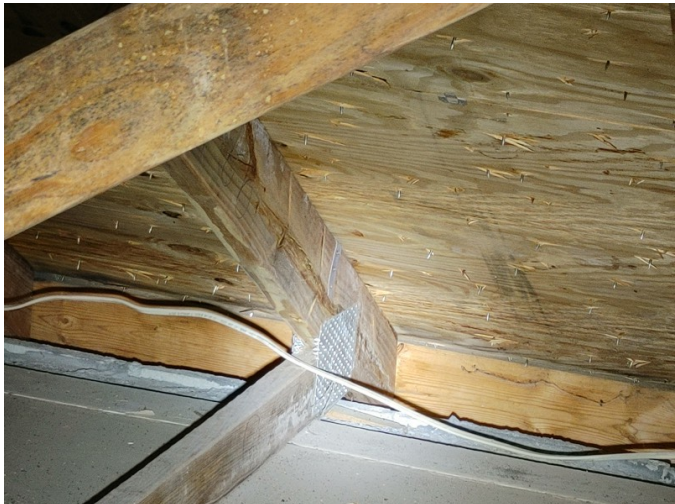
- ☒ C. Single Wraps
  - Metal connectors consisting of a single strap that wraps over the top of the truss/rafter and is secured with a minimum of 2 nails on the front side and a minimum of 1 nail on the opposing side.

Wrap with 2 nails and 1 opposite side
